# **ACTIVE CLEANING TECHNIQUE FOR REMOVING CONTAMINATION FROM OPTICAL SURFACES IN SPACE**

**FINAL REPORT  
D180-17610-1  
AUGUST 1973**

**CONTRACT NAS8-26385**

**BY  
Boeing Aerospace Company  
Research & Engineering Division  
Seattle, Washington 98124  
A Division of the Boeing Company**

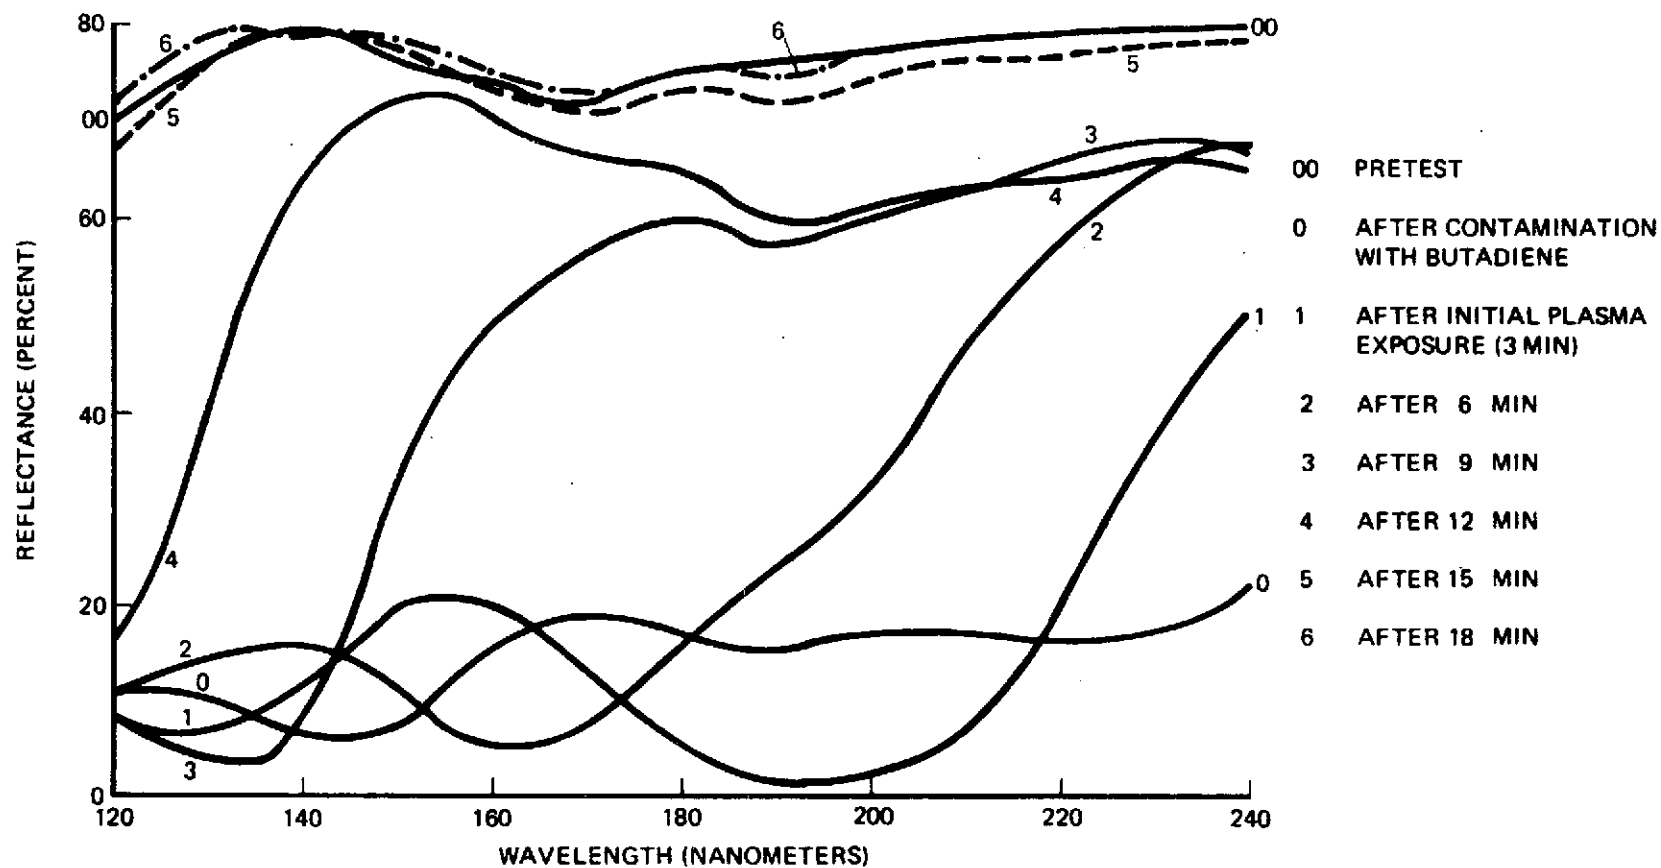
A similar set of experiments was conducted with a second  $1/2\lambda$  -  $\text{MgF}_2/\text{Al}$  coated UV reflecting mirror (MgF 56). Spectral reflectance data for this mirror is shown in Figure 12. The initial measurement of this mirror indicated higher reflectance in the region from 120 to 140 nm, and otherwise similar reflectance in comparison with MgF 39. MgF 56 with its companion QCM and IFM were then contaminated in the presence of 1 - 3 butadiene gas (chamber pressure about 4.0 torr) and UV radiation for 320 minutes. The resulting degradation in reflectance (as much as 75 percent) was less than the degradation observed with MgF 39. The QCM recorded a frequency change of 200 Hz. Interferometry indicated a deposited film thickness of about 30 nm. MgF 56 with QCM and IFM were then treated in a series of six plasma exposures of 3 minutes each. Plasma operating conditions were the same as before except the r.f. power was set to 30 watts. Reflectance measurements indicated a trend observed previously with MgF 39 whereby restoration occurred first in the longer wavelength region and, with successive exposures, extended into the shorter region. Following the first two plasma exposures, reflectance maxima and minima in the shorter wavelength regions (120 to 200 nm) were observed to shift their wavelength position. This is an expected interference phenomenon observed with small changes in the thickness of initially thin films. Following the sixth plasma exposure, a total exposure time of 18 minutes, the initial reflectance of MgF 56 had been totally restored within the wavelength region from 120 to 240 nm.

Figure 12: EFFECT OF BUTADIENE CONTAMINATION AND PLASMA EXPOSURE ON REFLECTANCE OF  $1/2\lambda$ -Mg F<sub>2</sub>/Al-COATED MIRROR (NO Mg F-56)

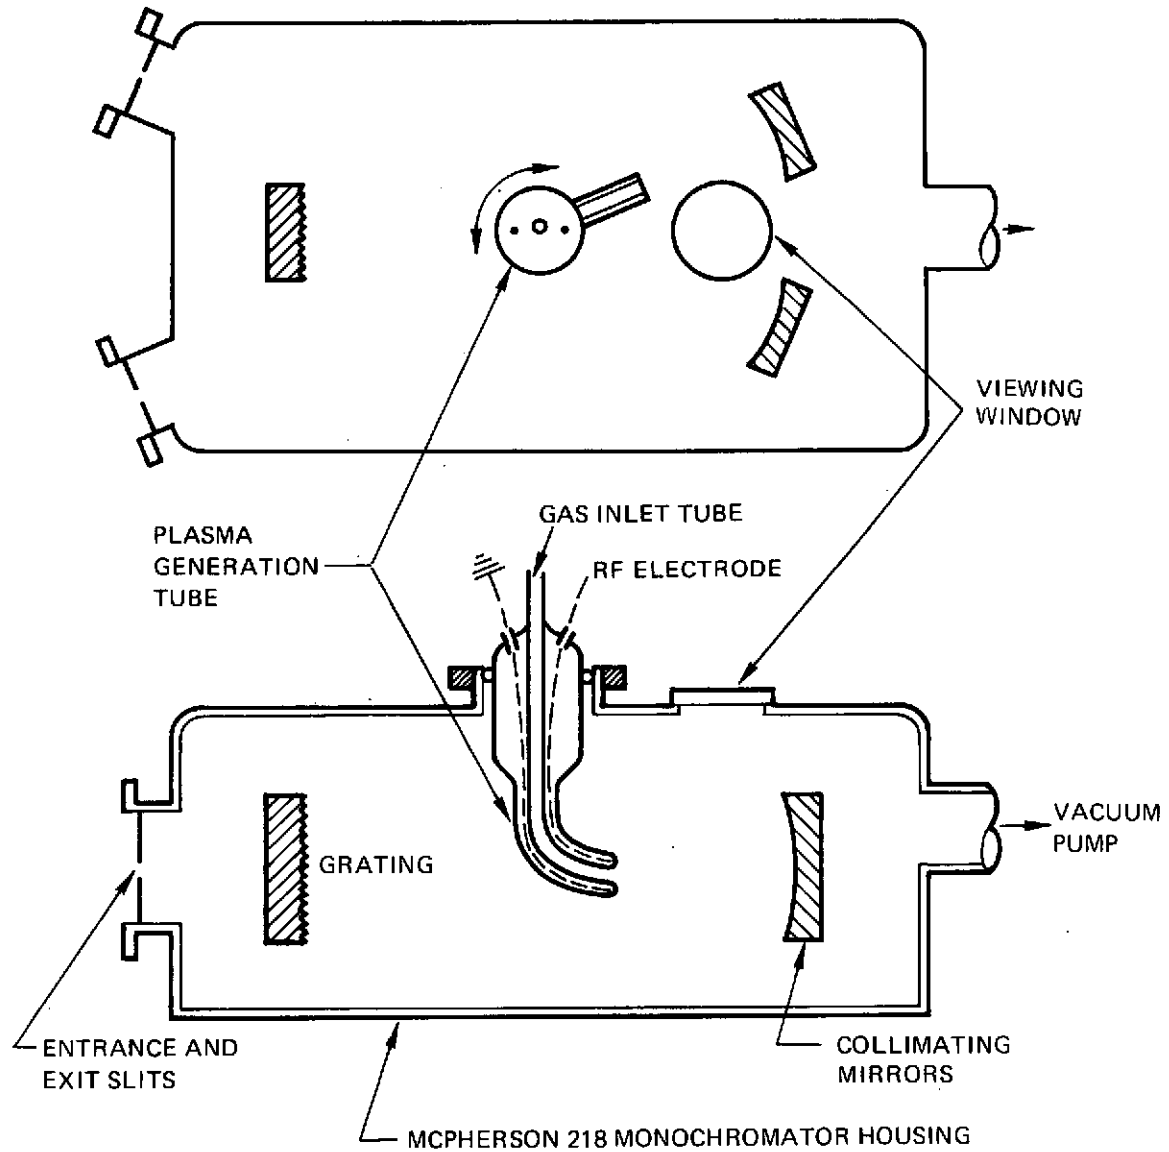
A plasma cleaning device was then fabricated and installed in the monochromator as shown in Figure 13. The quartz plasma tube assembly and a viewing window were both installed in the monochromator cover plate. An O-ring seal was used for the plasma tube to facilitate rotation to each of the three optical surfaces. During normal operation of the monochromator the plasma tube is removed and a suitable sealing plate is installed in its location.

*Figure 13: SCHEMATIC SHOWING INSTALLATION OF PLASMA CLEANING  
DEVICE IN McPHERSON 218 MONOCHROMATOR*

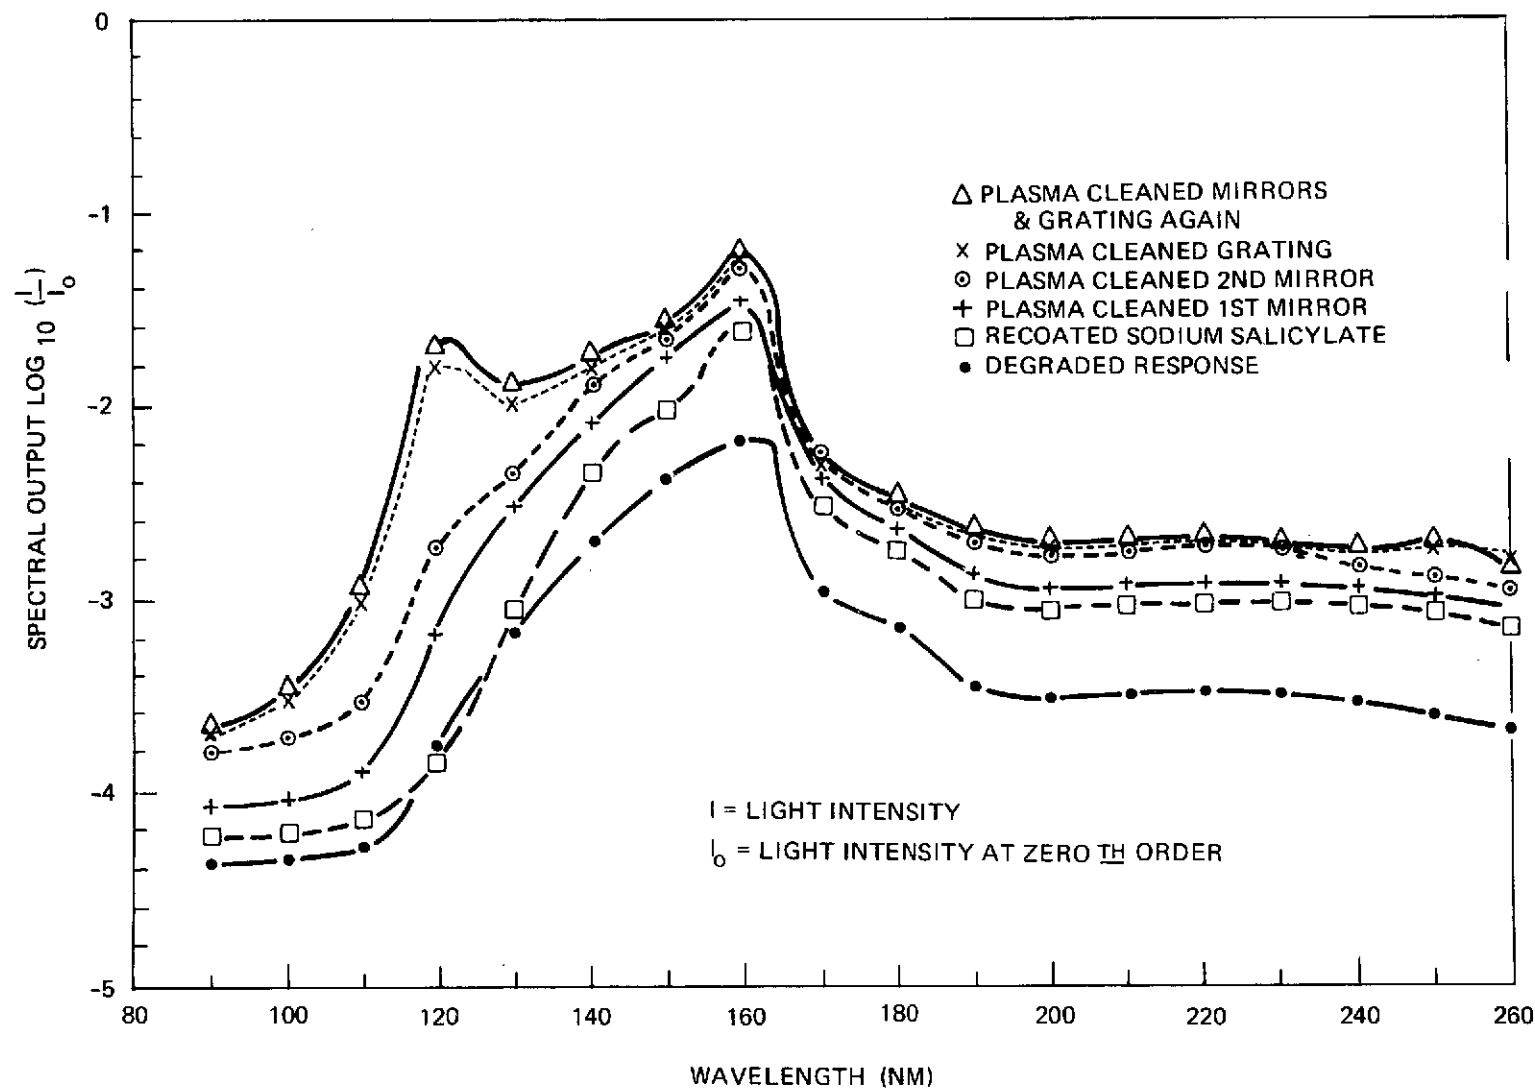
Figure 14: UV MONOCHROMATOR OUTPUT

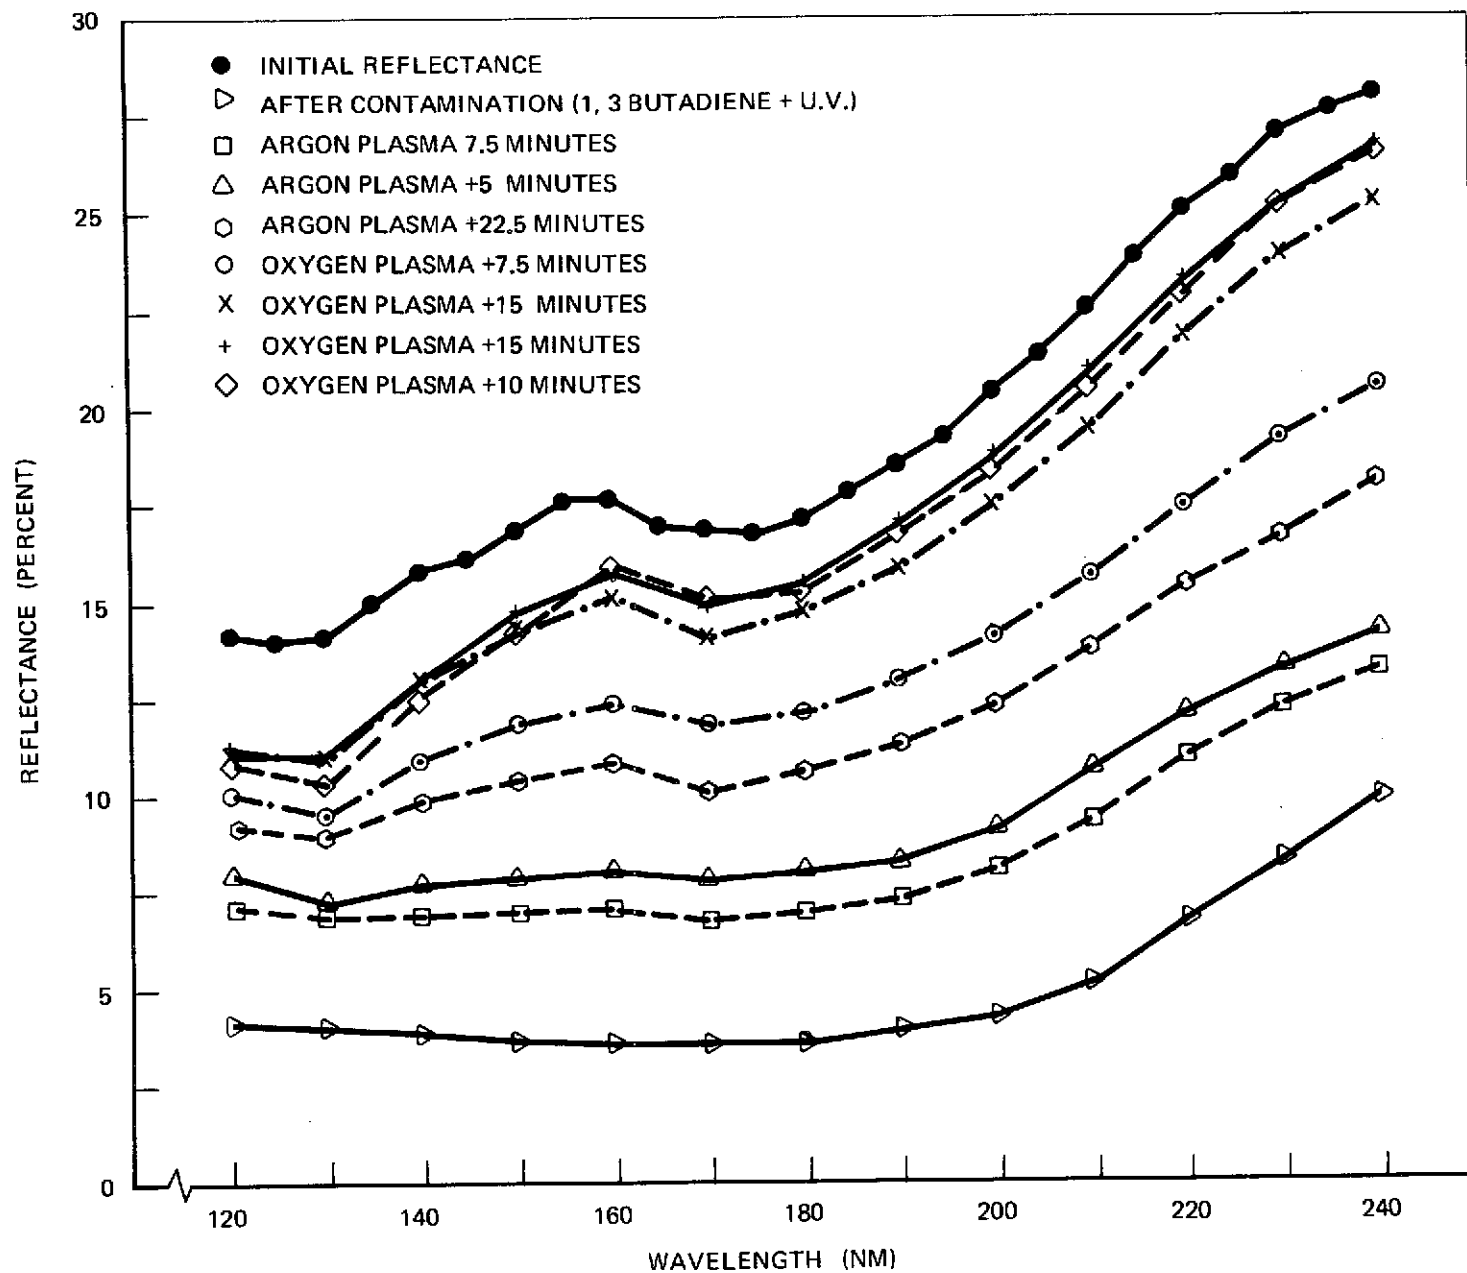
Figure 15: REFLECTANCE DATA FOR GOLD COATED MIRROR Au 6

experiment was to determine the effect of exposure to an argon plasma. Figure 15 shows that the argon plasma removes the contaminant film. Instead of continuing the argon plasma exposures it was decided to see if an oxygen plasma would clean more rapidly. The data in Figure 15 do not indicate any apparent differences in cleaning rate. Since the reflectance was not completely restored, the question is raised as to whether or not the order of exposure (in this case argon first and then oxygen) affects the contaminant cleaning. Data for this sample show that a short term (one hour) exposure to ambient air does not change the contaminant film effects on the UV reflectance. A slight degradation of UV reflectance occurred during an extended period (3 days) under vacuum (see Figure 16). The data in Figure 16 also show that monochromator optics degradation influences the reflectance data measurements in the 120 to 140 nm wavelength region.

Table 5 gives the 'log of events' for gold coated mirror sample Au6. Figures 15 and 16 show the reflectance data for this sample. The primary objective of this

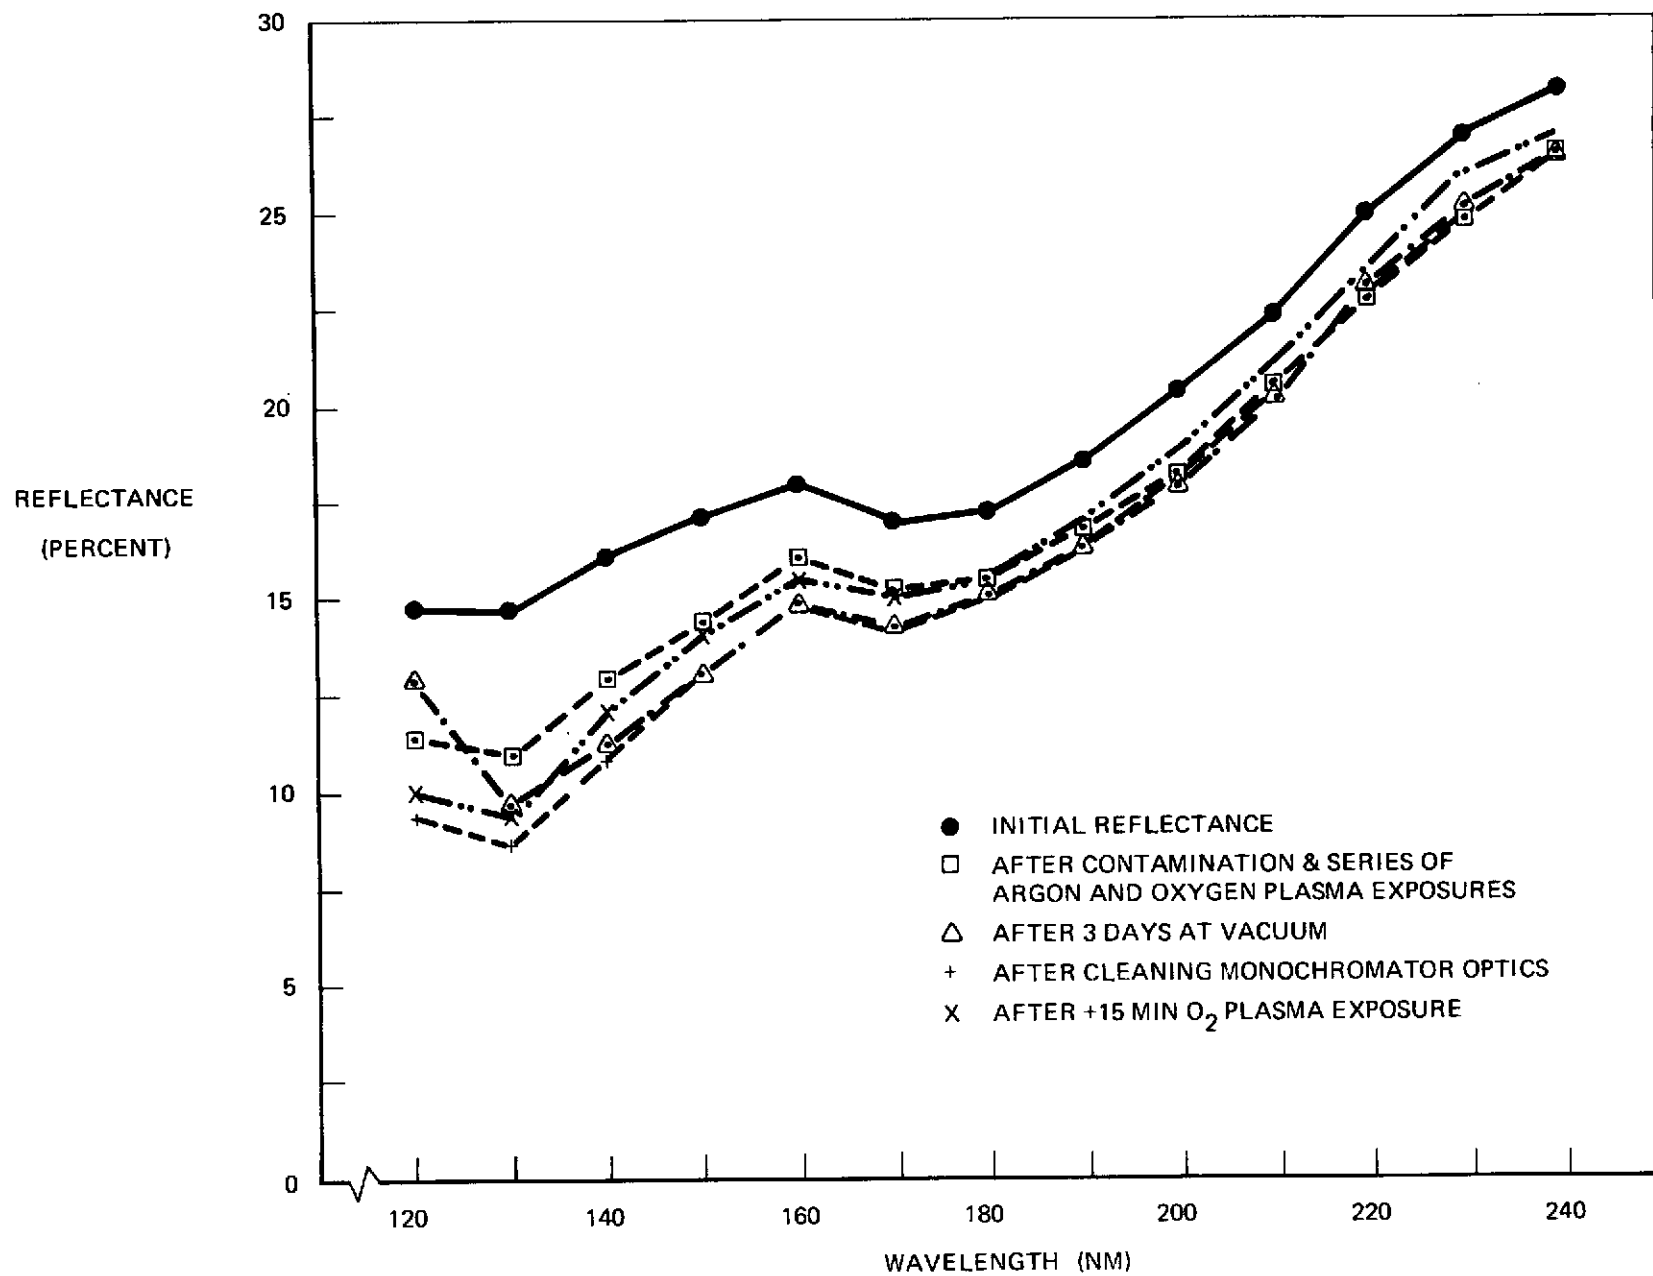
Figure 16: REFLECTANCE DATA FOR GOLD COATED MIRROR Au: 6

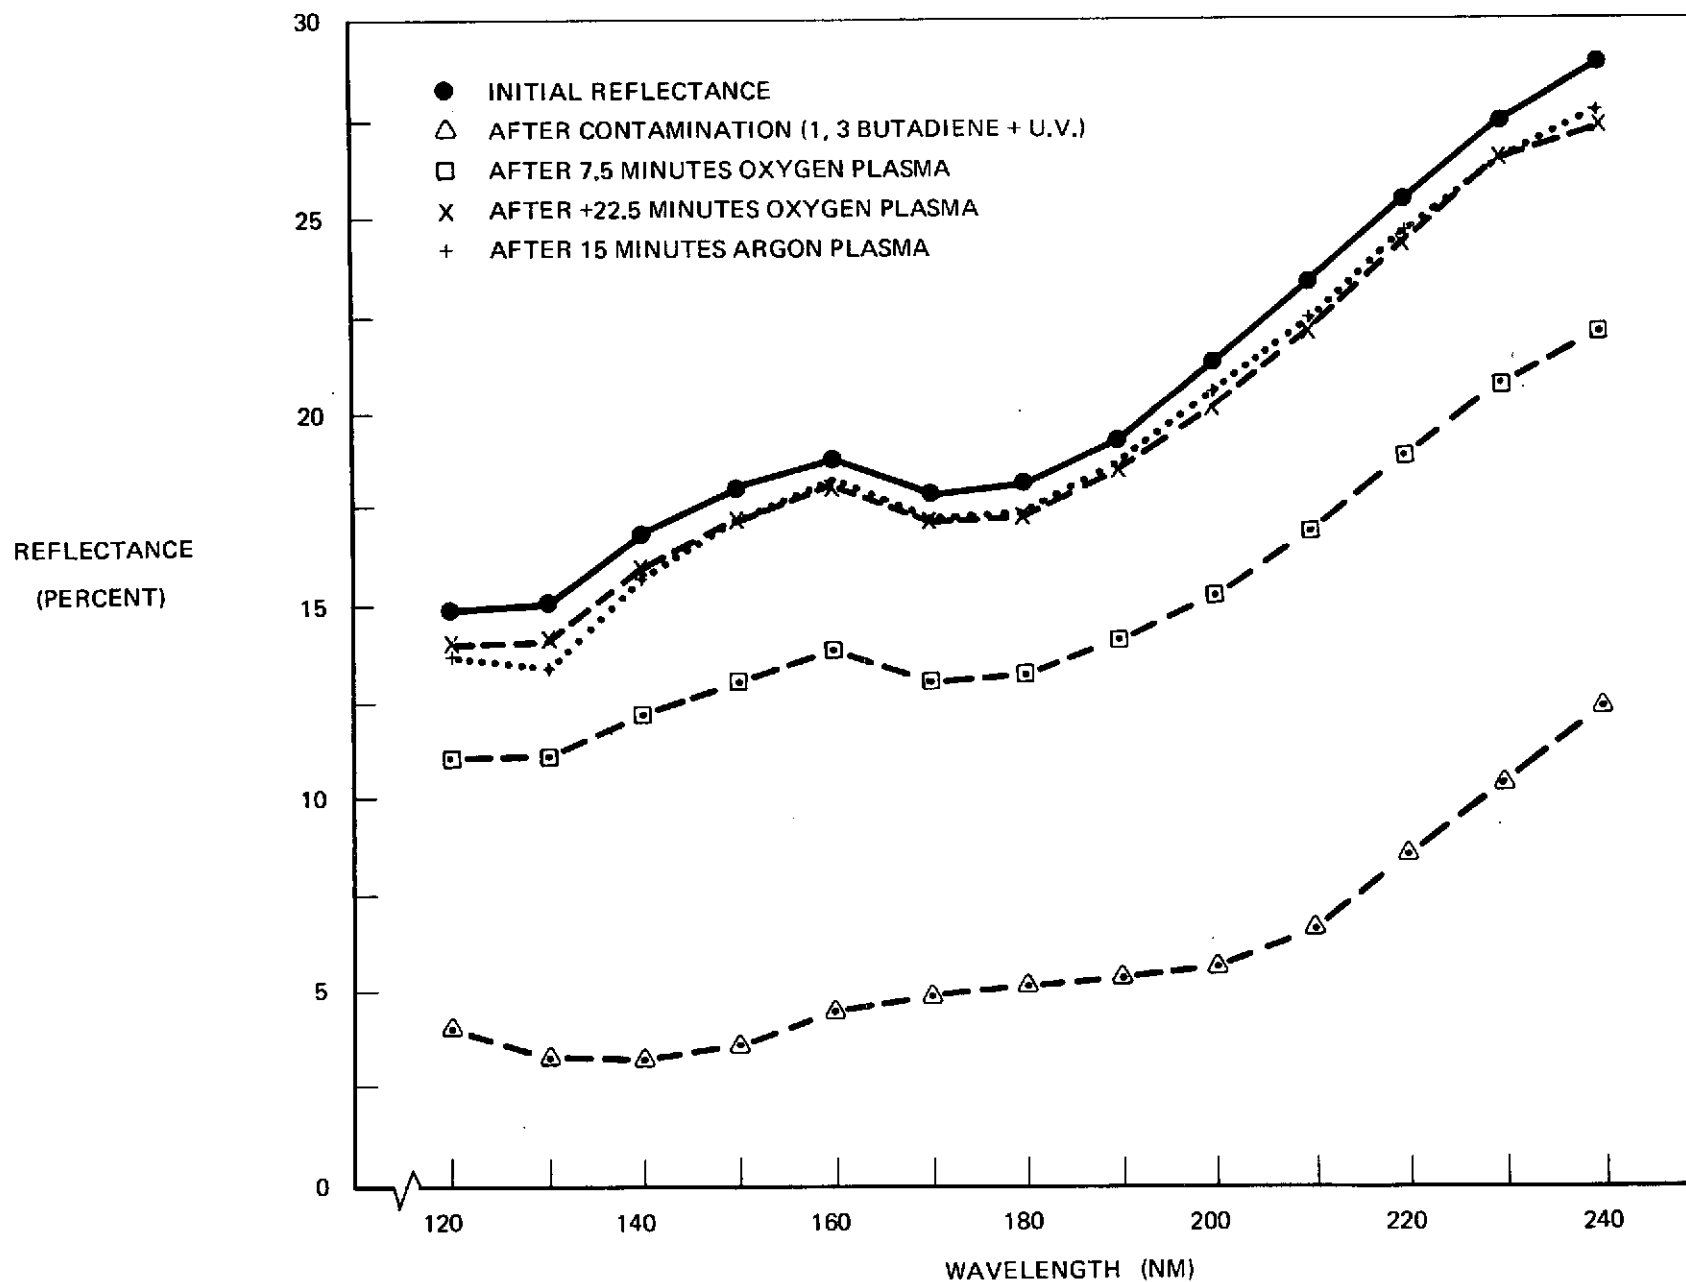
Figure 17: REFLECTANCE DATA FOR GOLD COATED MIRROR Au 7

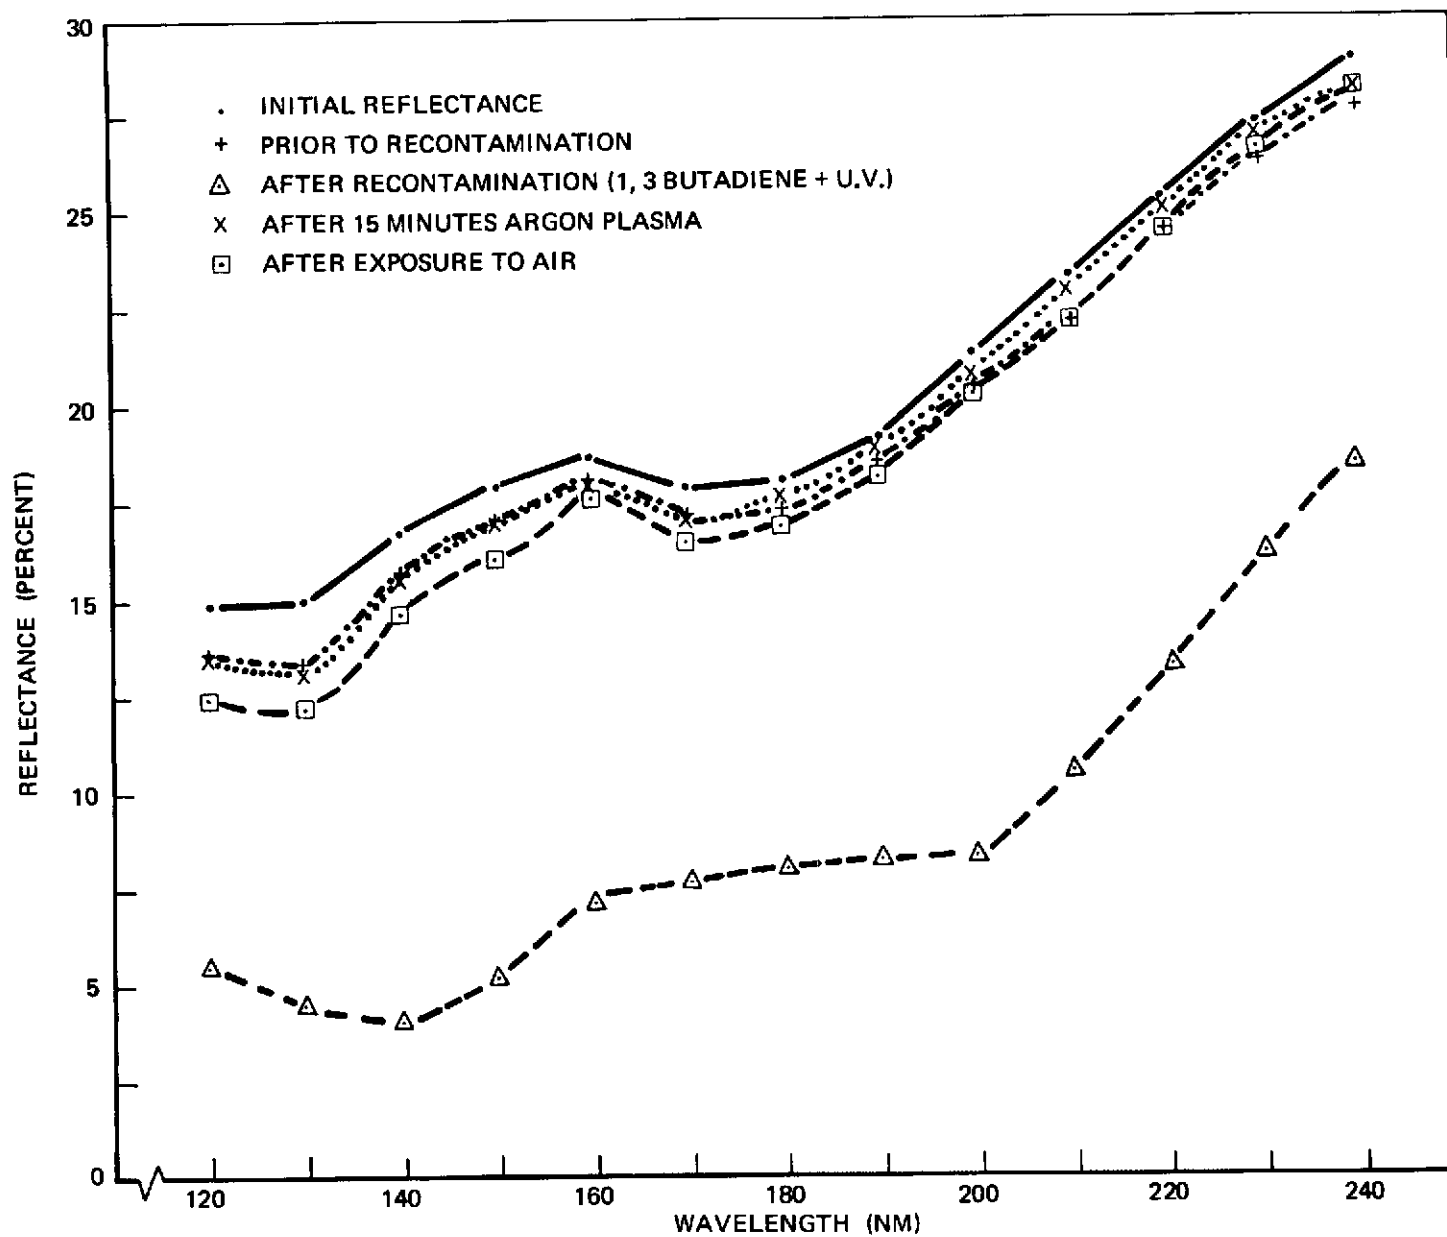
Figure 18: REFLECTANCE DATA FOR GOLD COATED MIRROR Au 7

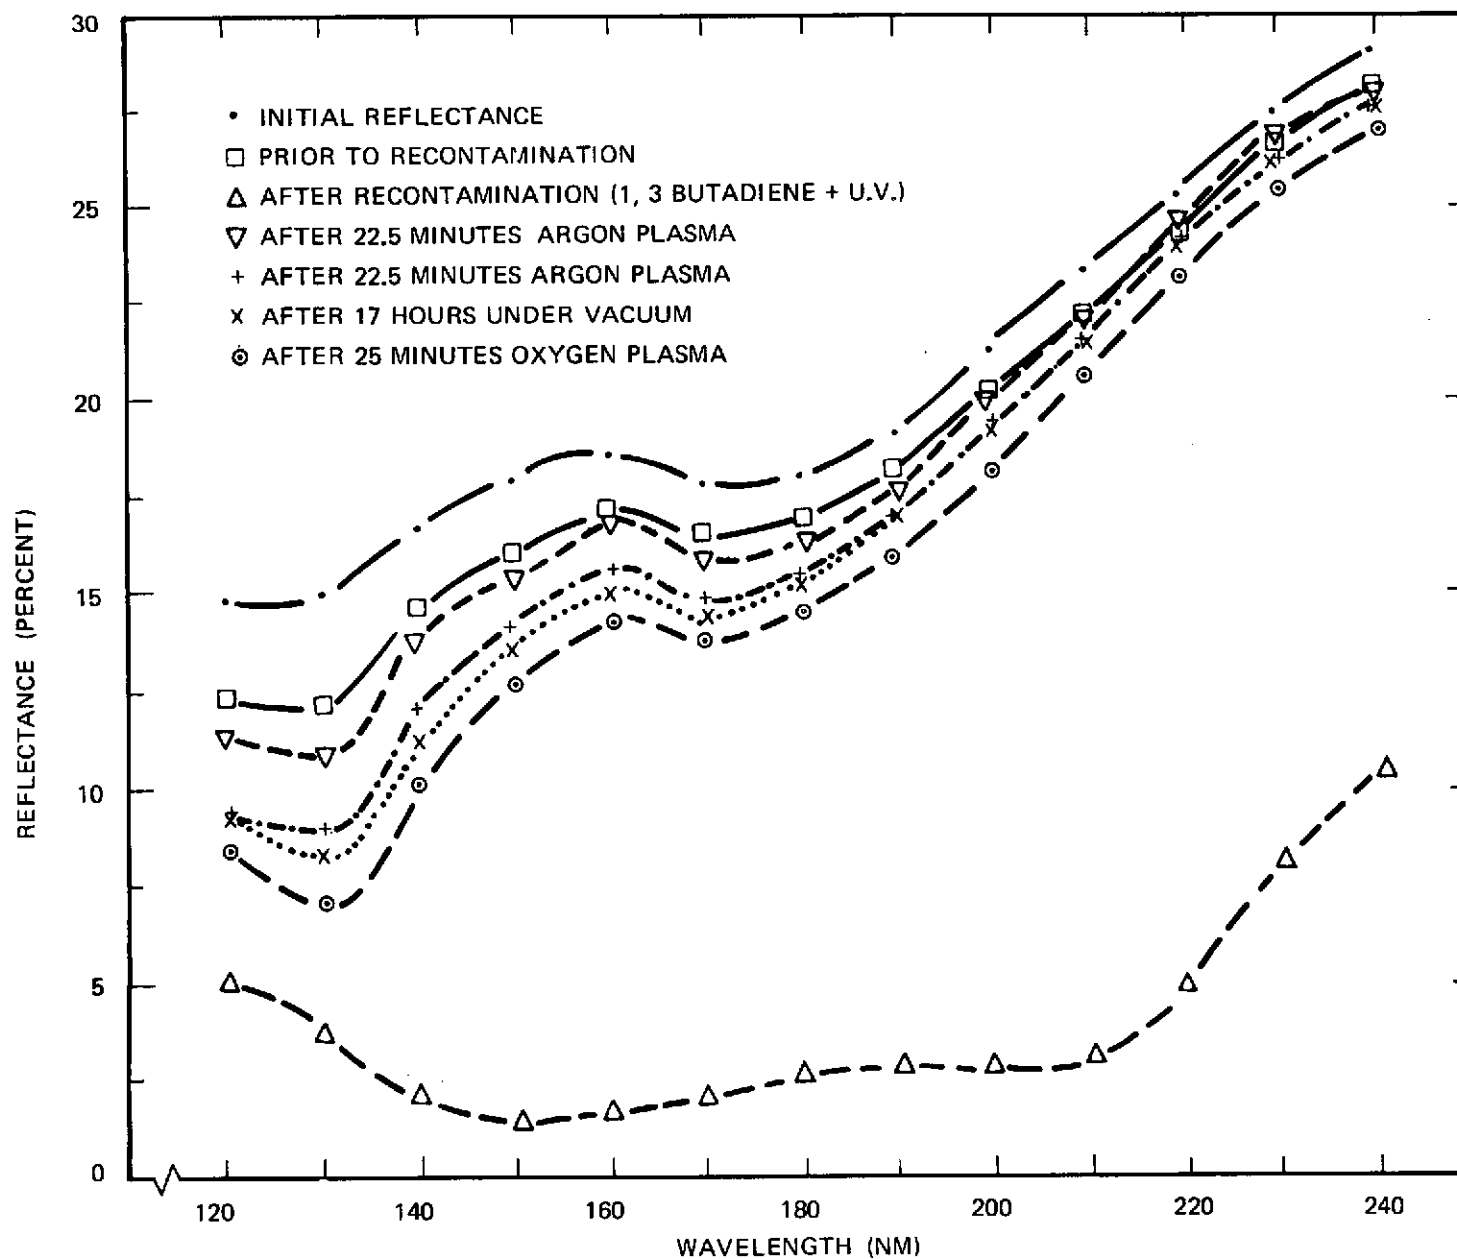
Figure 19: REFLECTANCE DATA FOR GOLD COATED MIRROR Au 7

Following the argon plasma cleaning, sample Au7 was recontaminated and exposed to ambient air for 20 hours. This ambient air exposure had no measurable effect on the degraded UV reflectance of the sample. Figure 19 shows that a 22.5 minute argon plasma exposure nearly restored the UV reflectance to that prior to recontamination. However, an additional 22.5 minute argon plasma exposure produced degradation in the reflectance. Leaving the sample exposed to vacuum for 17 hours resulted in slight further reflectance degradation. This result is consistent with that observed for sample Au6. Apparently contaminants from the closed-off vacuum system deposit on the cooled sample to some degree. An additional 25 minute exposure to an oxygen plasma produced further reflectance degradation. The results of the final plasma exposures indicates 'over cleaning' of the sample.

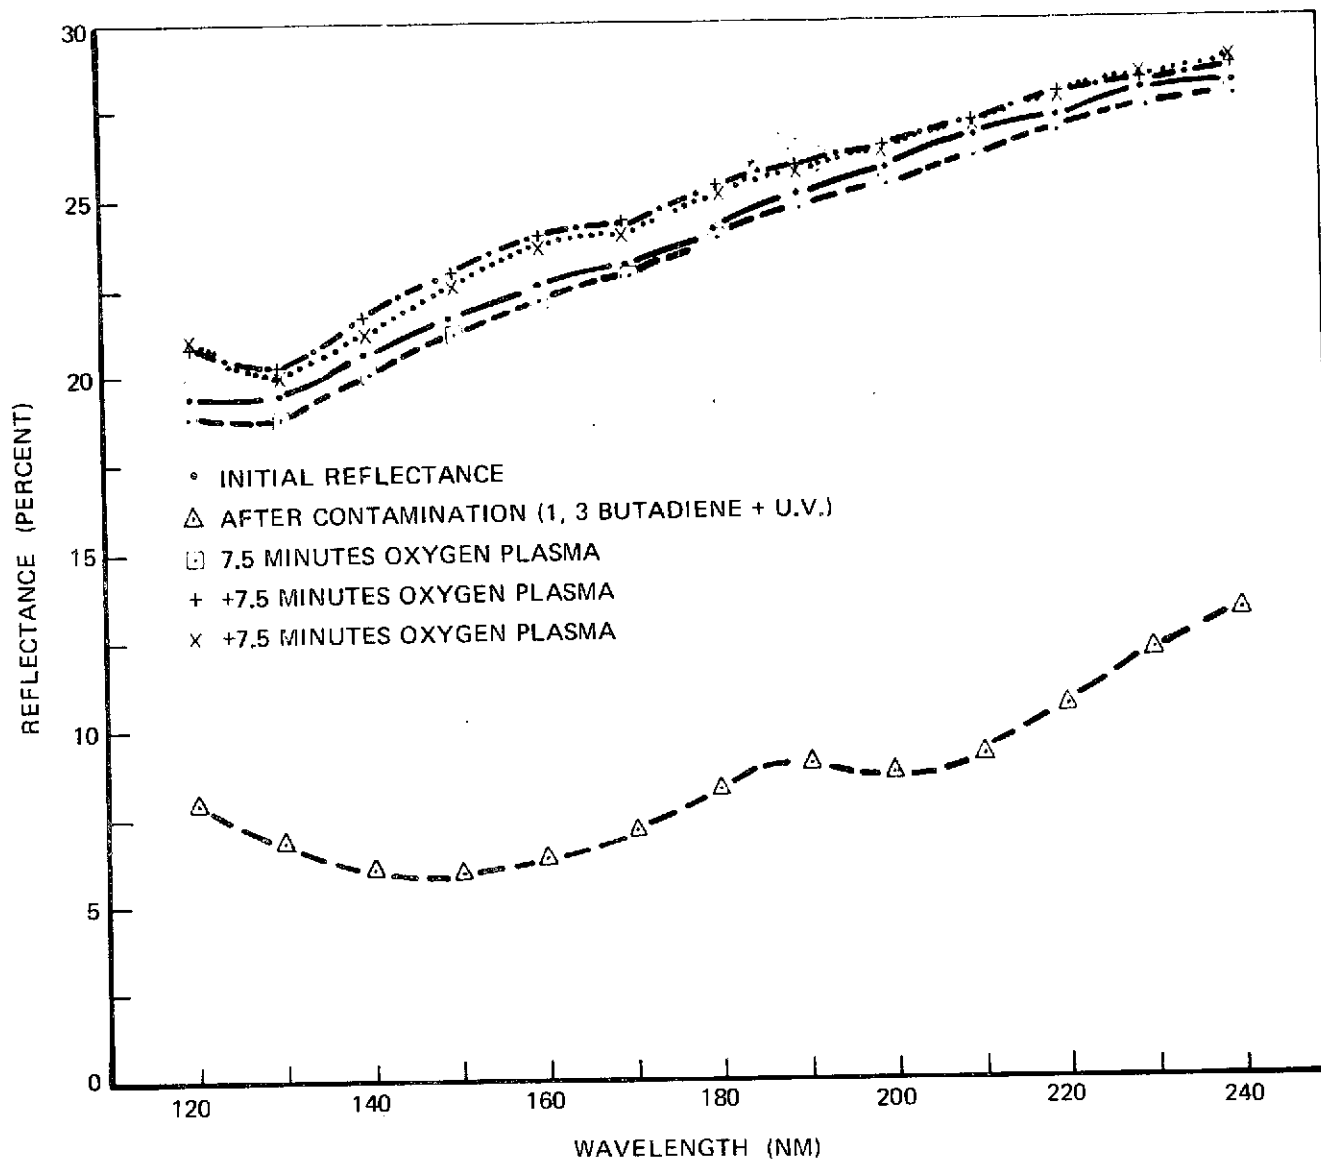
Table 7 gives the 'log of events' for the experiment using platinum coated mirror Pt 14. The reflectance data for this sample are shown in Figures 20 and 21. Figure 20 shows that the degradation, produced by the butadiene contaminant film, was almost eliminated with a single 7.5 minute oxygen plasma exposure. A second exposure increased the reflectance beyond that prior to contamination. A third exposure produced little effect. The sample was then contaminated again and left under vacuum, with the vacuum system closed-off for 65 hours. Figure 21 shows the amount of degradation still present after this extended period under vacuum. The degree of degradation is less than that shown in Figure 20. Some of the contaminant film may have been removed by the extended period under vacuum, however, it should be noted that the initial contamination produced a film six times thicker than that produced in the recontamination. Consequently, the primary reason for the differences in degree of degradation is probably the amount of contaminant film deposited rather than the effects of the extended vacuum exposure. A 7.5 minute oxygen plasma exposure essentially restored the reflectance to its value prior to recontamination. A second exposure produced little change in the reflectance. However, after plasma cleaning the monochromator optics, a remeasurement of the reflectance showed slight degradation in the 120-150 nm wavelength region. This again indicates that the degradation of the monochromator optics influences the reflectance measurements in the shorter wavelength region.

Figure 20: REFLECTANCE DATA FOR PLATINUM COATED MIRROR Pt 14

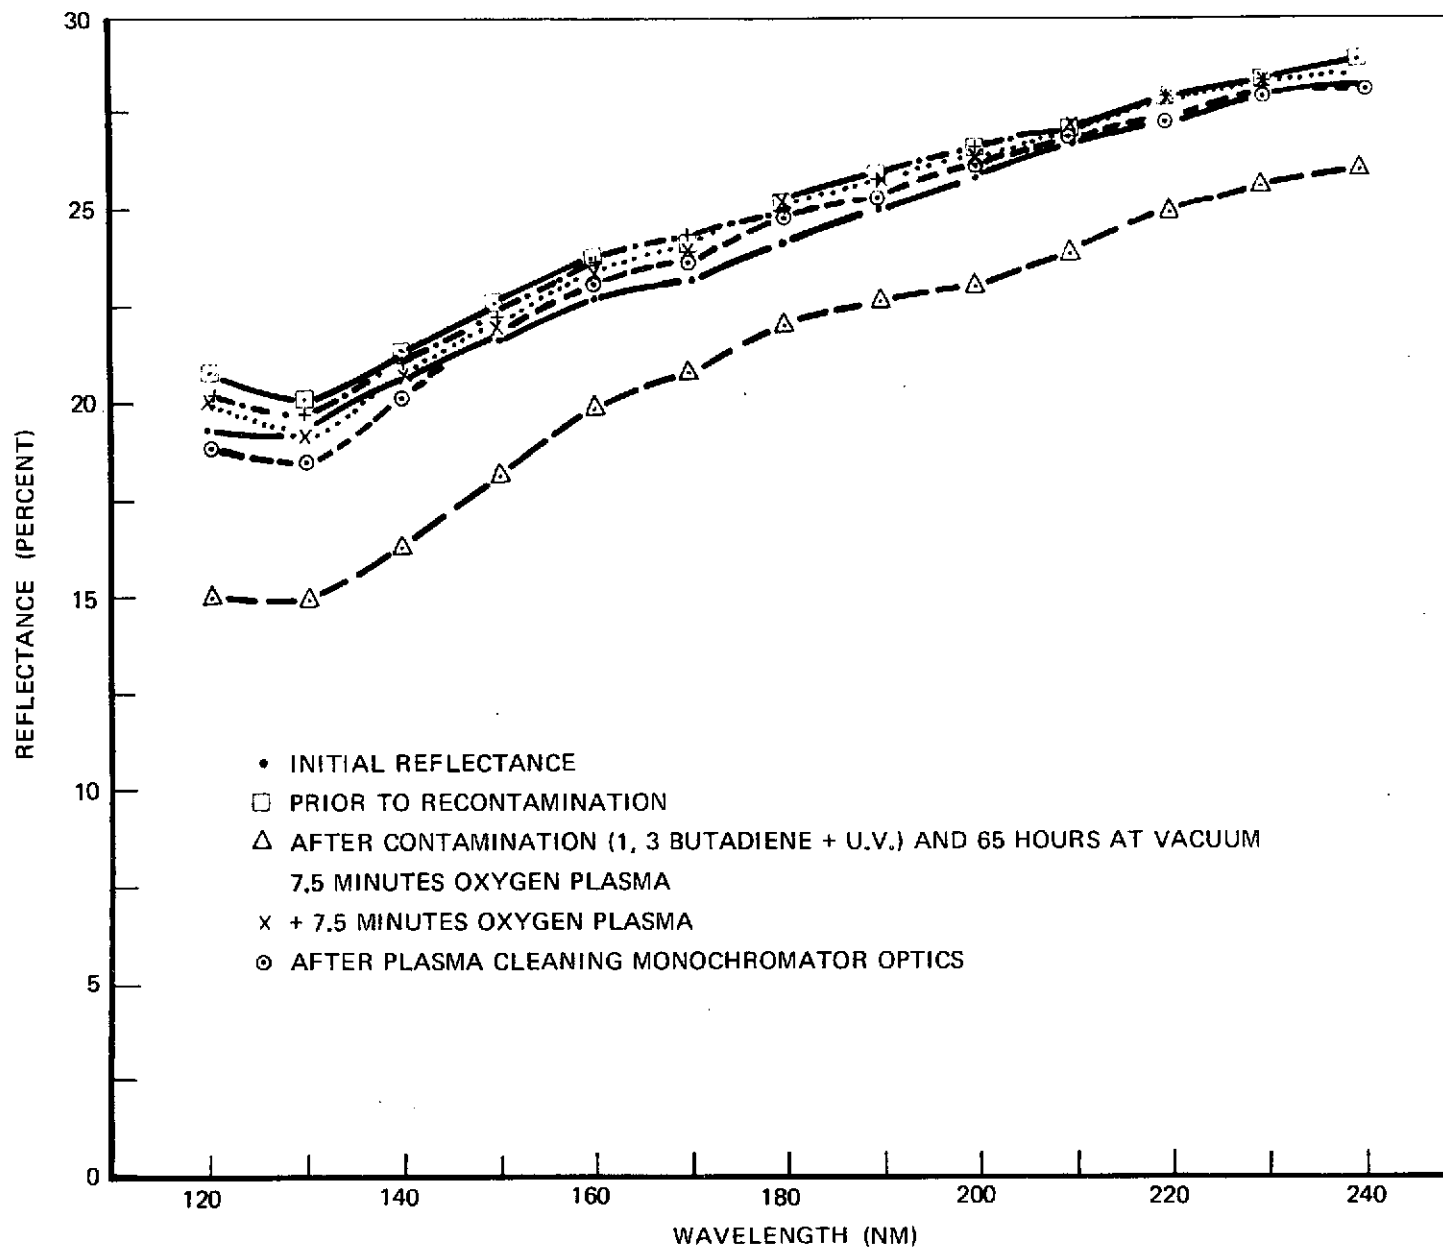
Figure 21: REFLECTANCE DATA FOR PLATINUM COATED MIRROR Pt 14

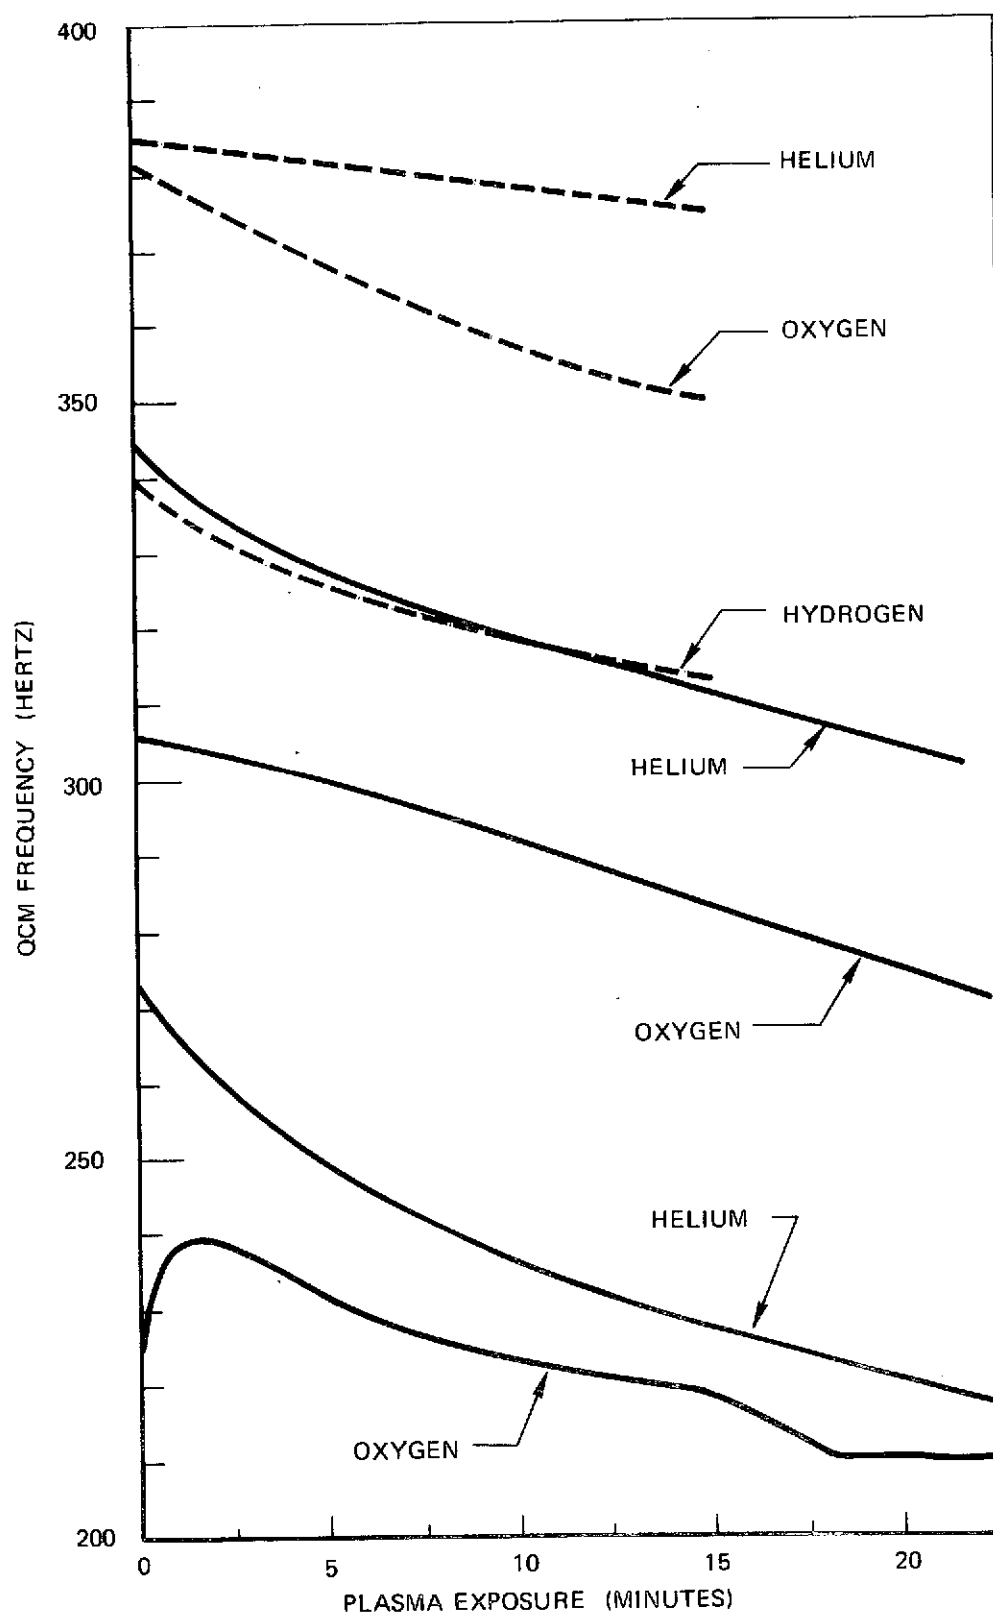
Figure 22: PLASMA CLEANING OF CARBON COATED QCM

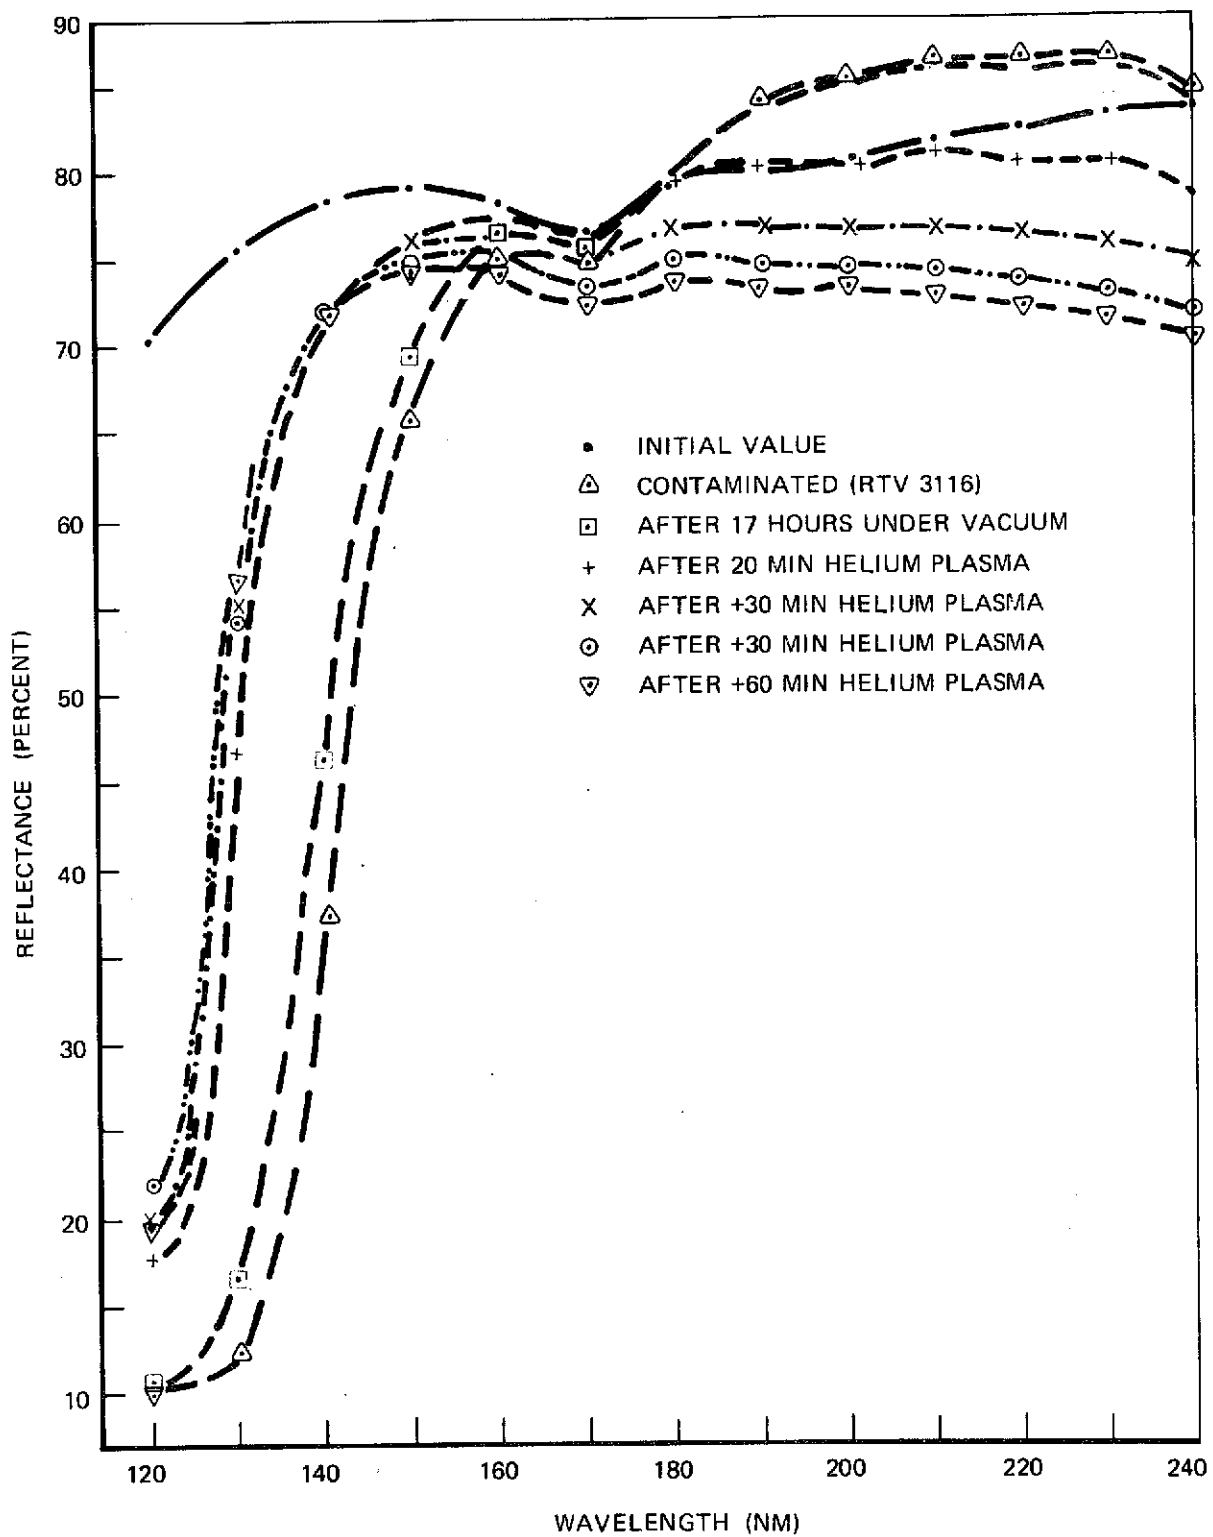
The first  $\text{MgF}_2/\text{Al}$  mirror (MgF 113) was exposed to the outgas products of RTV3116 for 24 minutes. The QCM response indicated a contaminant film deposition of about  $2 \times 10^{-6} \text{ gm/cm}^2$ . The UV reflectance of the sample was severely degraded in the 120-140 nm wavelength region and was increased in the 180-240 nm wavelength region (Figure 23 shows the reflectance data for sample MgF 113). As shown in Figure 23, some of the contaminant film appears to have evaporated during a 17 hour period under vacuum. The sample was then subjected to a series of helium plasma exposures (the first for 20 minutes, then four of 30 minutes each). These exposures increased the reflectance at the shorter wavelengths and decreased it at the longer wavelengths (see Figure 23). The restoration at the shorter wavelengths appeared to be limited, whereas, the degradation at the longer wavelengths appeared to be progressive. A subsequent 15 minute exposure to an oxygen plasma (results not shown in Figure 23) resulted in very little change in reflectance except for a slight degradation in the 120-140 nm wavelength region.

Figure 23: REFLECTANCE DATA FOR Mg F<sub>2</sub>/Al MIRROR Mg F113
